Renovation indoor swimming pool, Burgdorf

2010

The project

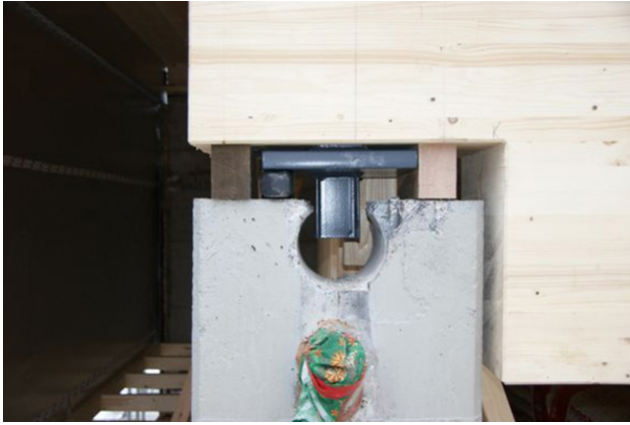
Support before casting

Twin beams were installed on both sides of the existing beams and braced with additional doublers on both sides of the concrete columns. A Lignotrend acoustic ceiling was installed under the new rafter purlins. The indoor swimming pool The construction method of the indoor swimming pool and the size of the girders did not allow renovation from below. Therefore, a different approach was chosen for the indoor swimming pool. The existing supporting structure, including the roofing, was removed section by section and completely replaced. Here, too, glulam beams were used. The increased risk of corrosion of metal parts necessitates the use of highly corrosion-resistant and correspondingly expensive steel grades. To take account of this, both main and secondary beams were directly supported throughout the building, without any statically loaded steel parts. Special care was taken to seal the roof, exterior walls and connections.

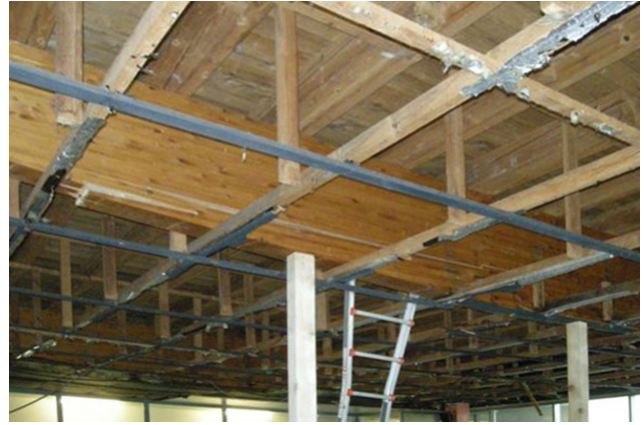
Existing supports

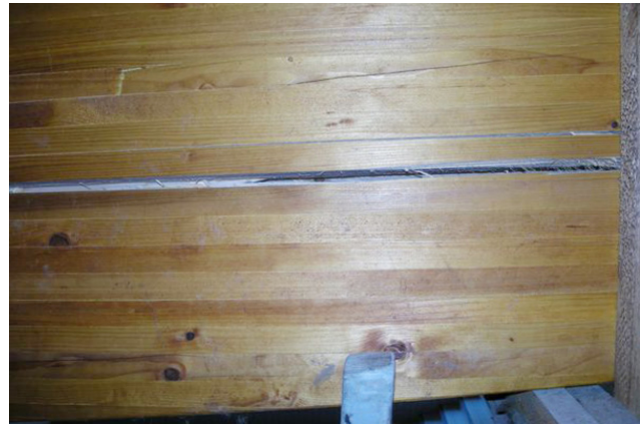
During the inspection of a steel beam, cracks were found in the adjacent wooden beams. Not nice conditions for a well-attended indoor swimming pool! But Timbatec had the solution.

Cracks with consequences: The discovery of the cracks in the primary beams were the trigger for the immediate closure of the indoor pool and the learning pool. Timbatec's proposal to first make the small learning pool usable in order to be able to resume the existing swimming and water courses as soon as possible met with approval. During the renovation of the learning pool, the renovation of the indoor pool roof was planned and prepared. The renovation of the learning pool took three months, while the renovation of the indoor pool took another four months. The learning pool: The new structure was inserted into the existing one from below in order to preserve the recently constructed flat roof insulation and waterproofing. The structure was made stronger for a possible single-story addition.

Cracks
