# Renovation and extension sports center, Gstaad

2018

Gstaad has made its sports center fit for the future. In addition to the construction of a wellness area, the wooden support structure of the indoor swimming pool was extensively renovated. Timbatec analyzed its condition and defined the renovation measures.

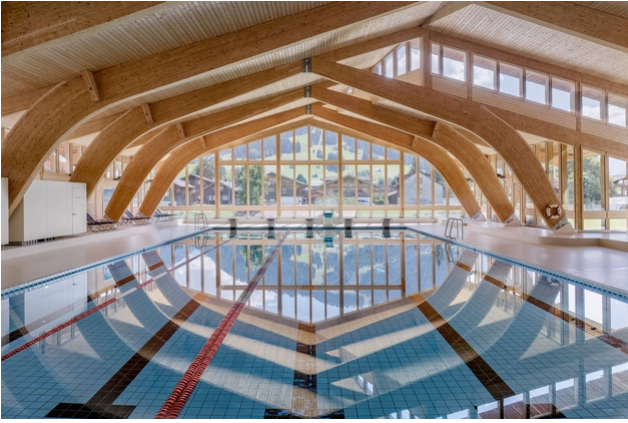
Impressive dimensions: supporting structure of the indoor swimming pool

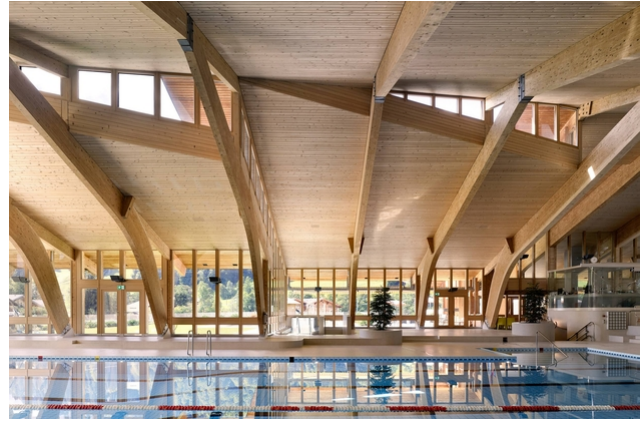
Between the trusses was renewed acoustic paneling

In order to reinforce individual trusses, lamellas made of glulam were glued on. In addition, the roof was thermally renovated. The boarding between the trusses was removed, the roof was insulated from the inside and provided with a new formwork. Timbatec was responsible for quality assurance of the refurbishment work and also for fire protection for the entire project.

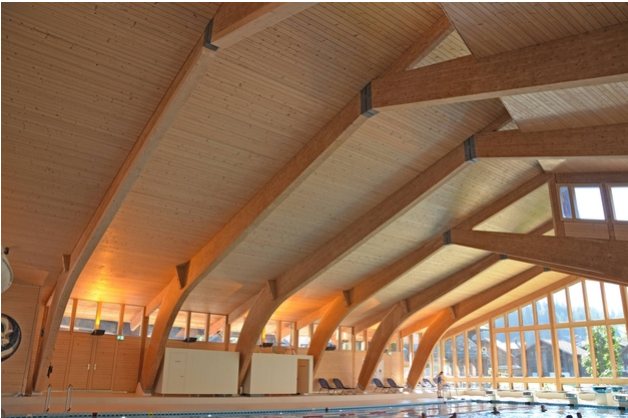
The beam on the far left is additionally reinforced with slats

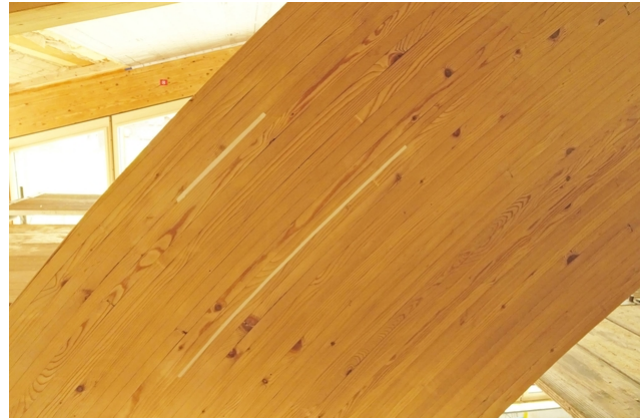
Detailed view of a rehabilitated adhesive joint

The Gstaad indoor swimming pool, built in 1971, is the oldest indoor swimming pool in Switzerland with a three-hinged arch supporting structure made of glulam. The pool has been a listed building for some time. The dimensions of the construction are impressive. The supporting structure consists of three-hinged arch trusses with spans of up to 34.2 meters and cross sections between 20 x 110 cm and 35 x 135 cm. But age has left its mark. Building technology, the drains as well as the building structure were partly outdated. In addition, cracks had appeared in the main supporting structure of the roof. Timbatec received the order to investigate the cracks. They were recorded and documented with a total station. It was found that certain cracks were so deep that the statics were no longer guaranteed. It was also found that the load on the main girders was too high in some areas. Crack repair was therefore necessary on the girders. The cracks were cut free, cleaned and adhesive was injected to close them.
